# ESAB ServiceTip

## PowerCut-875 & PowerCut-1125 Plasmarc™ Cutting Packages

### ISSUE: Air Fitting Clearance

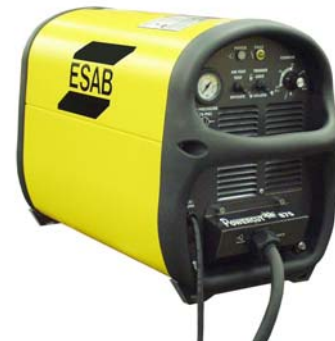
P/N 950512 - 45°-1/4" pipe street elbow

**FIX:** Use an optional 45° -1/4" pipe street elbow to provide necessary clearance for air coupling.

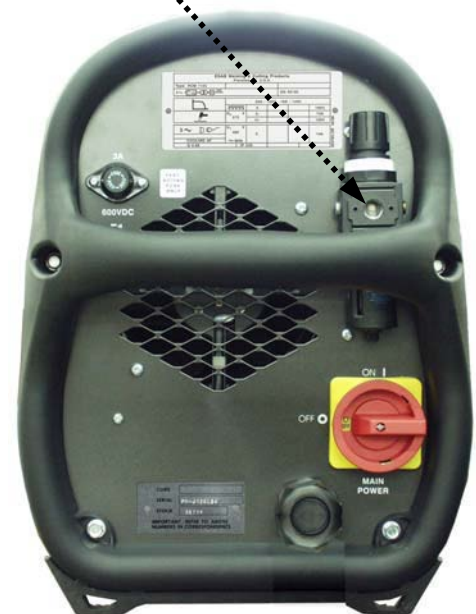
**DESCRIPTION:** On the first production run of the PowerCut 875 and PowerCut 1125 the air filter regulator output fitting was too low making assembly difficult due to interference with the carry handle. This only affects the initial production run of these units.

**NOTES:** This only affects the initial production run of these units as stated above. On all subsequent production units, the filter regulator has been moved upward to provide proper clearance.
